**Second  
International Conference  
on  
Case Histories in  
Geotechnical Engineering**

**June 1-5, 1988**

**University of Missouri-Rolla  
Rolla, Missouri**

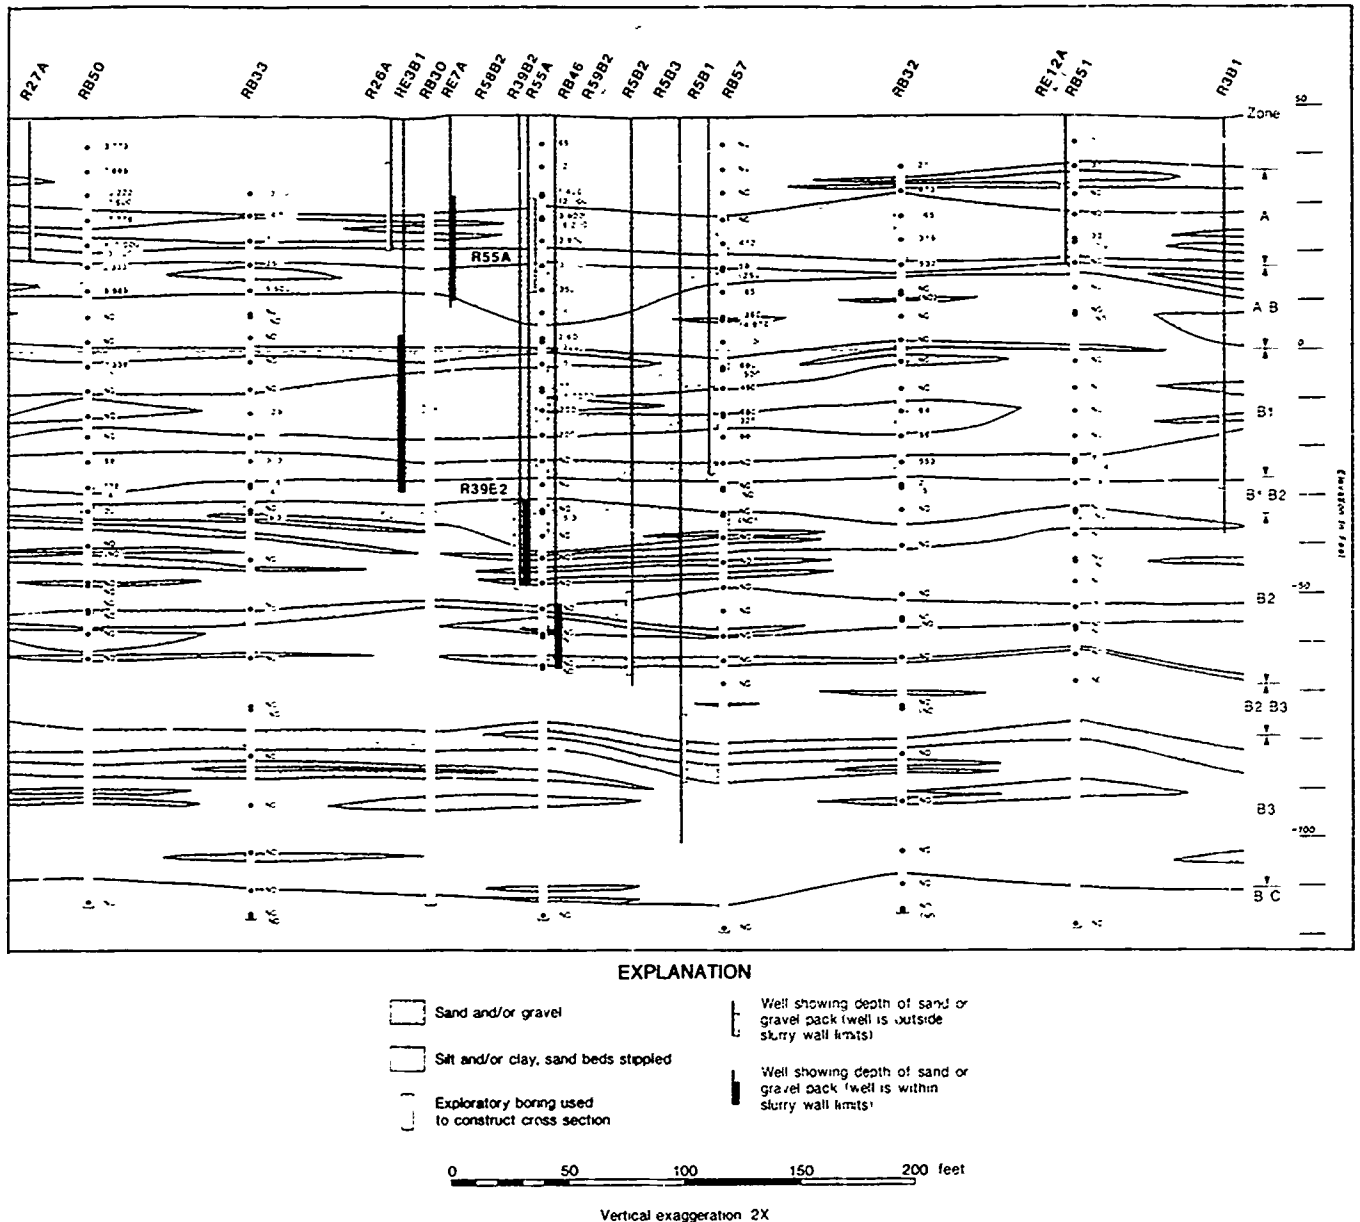
FIGURE 2. Typical Geological Cross Section (Along North Property Line)

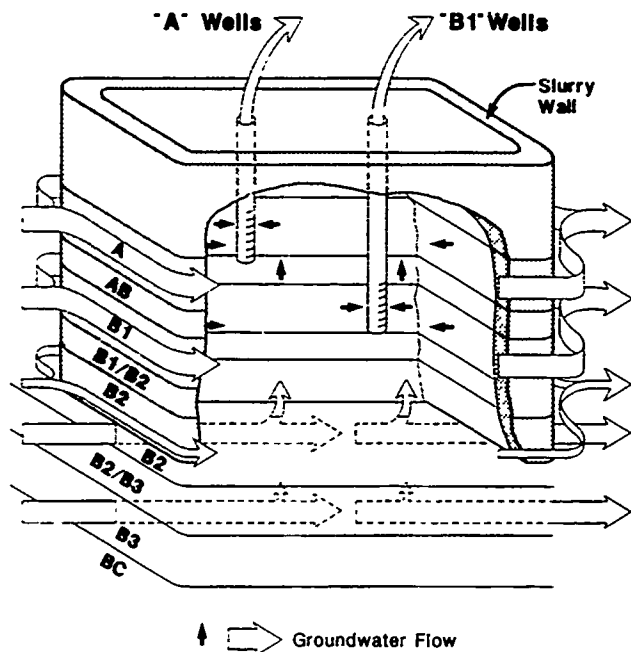
FIGURE 3. Slurry Wall Schematic

Conventionally, slurry walls have been tied in to a less permeable horizon for containment. After reviewing and assessing the site data, it was decided that this would not meet the remedial objectives. A novel concept was therefore developed in which the wall would be constructed to a predetermined depth around the site to act as a curtain within which pumping would accentuate inward and upward

hydraulic gradients and so stop further offsite migration of chemicals within the impacted zones (Figure 3).

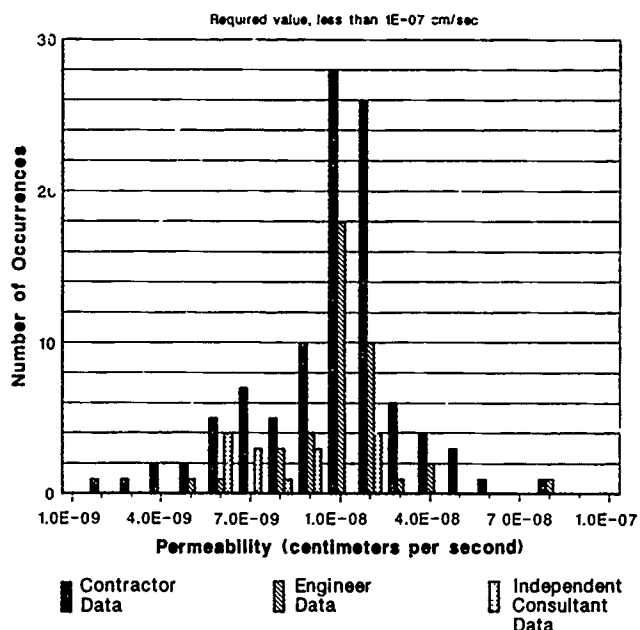
FIGURE 5. Histogram of Permeability Test Results by Laboratory

The results of the QA/QC showed that no non-compliant material was in the wall backfill. All the permeability test results, which are shown on Figure 5, were well below the required maximum.

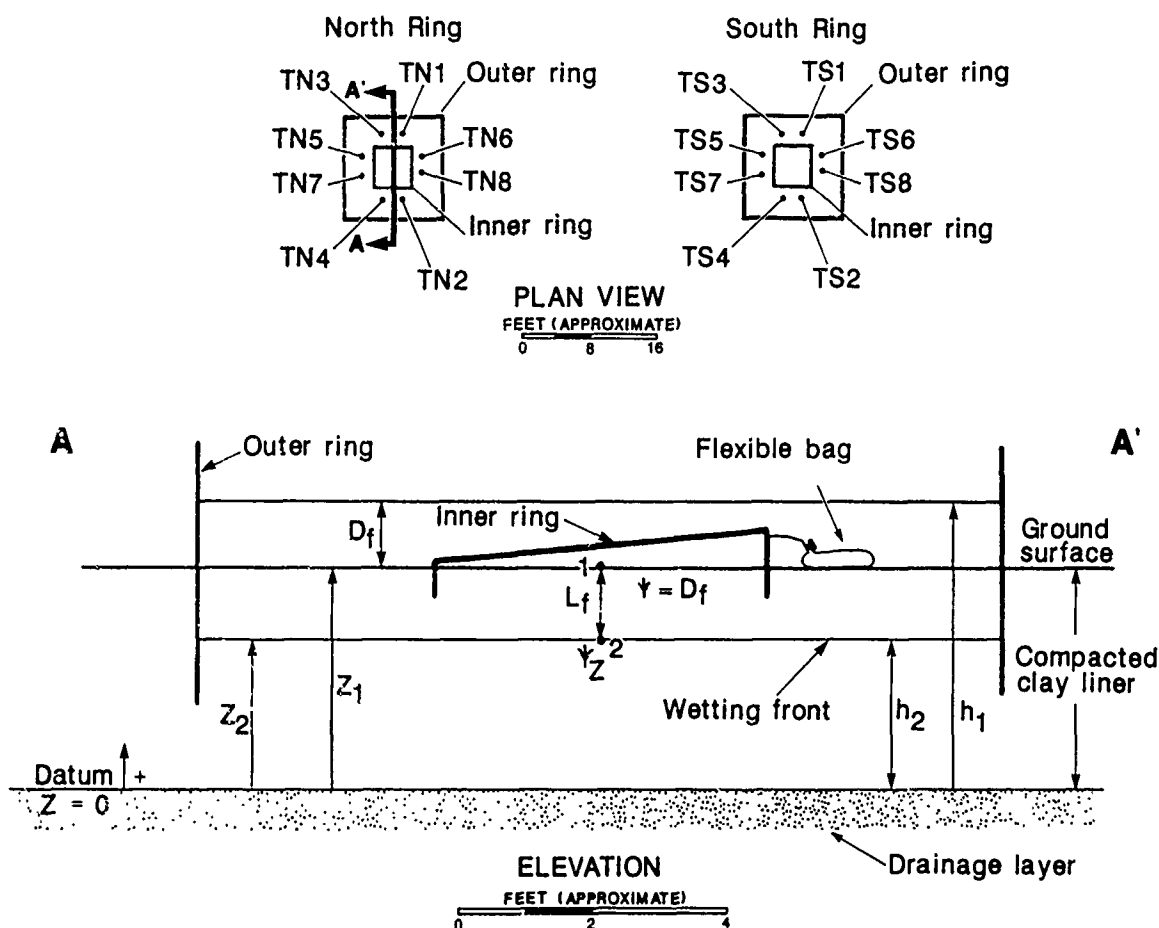
Figure 1. Infiltrometer Test Schematic

ponded water depth and soil suction (tension). The saturated hydraulic conductivity can be computed using a form of Darcy's Law which includes terms for the total hydraulic gradient. The governing equation that describes the flow of water into the compacted clay is developed below. Illustration of the terms and sign convention is shown in Figure 1.

as an average value. The soil suction ( $\bar{\psi}$ ) is set equal to the average soil tension preceding the passage of the wetting front. The infiltration rate ( $q$ ) is determined by weighing the flexible bag (Figure 1) periodically to determine the volume of water lost. The change in volume is then divided by the area of the inner ring and the elapsed time over which the volume change occurred. The values of  $q$ ,  $L_f$ ,  $L$ , and  $\bar{\psi}$ , are then used to back calculate  $K$  from

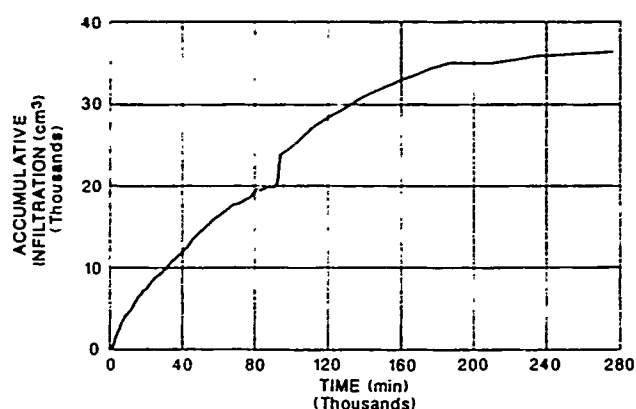
Figure 3. Accumulative Infiltration Versus Time (South Ring)

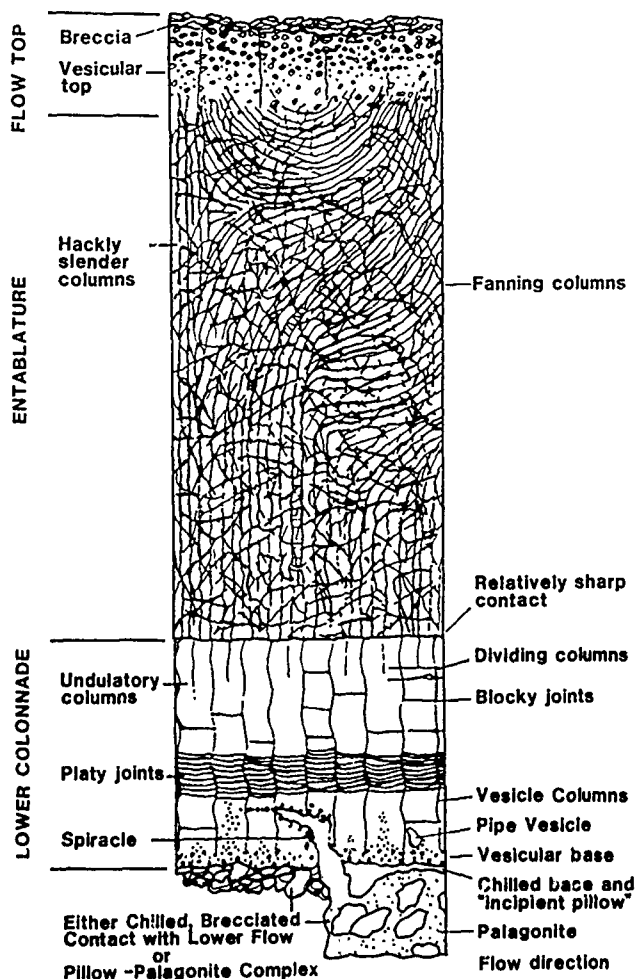
Figure 4 Generalized Schematic Diagram Showing Structure of a Basalt Flow

The upper Priest Rapids flow varies from approximately 60 to 95 feet in thickness at the site. In outcrops in Alkali Canyon southwest of the site, the upper Priest Rapids flow is characterized by well developed columnar jointing ranging from four to eight feet in diameter and rise from the base of the flows for two-thirds to three-fourths the total thickness. Nearly vertical and roughly hexagonal in cross section, these columns are cut into sections by subhorizontal cross-joints with highly variable spacing (0.5 to 10 feet). Randomly oriented joints frequently extend through the upper part of the colonnade. These random joints increase in density upwards, creating a brickbat jointing pattern which forms the upper one-third to one-fourth of the flow. A generalized schematic diagram showing the structure of a typical basalt flow is shown in Figure 4.

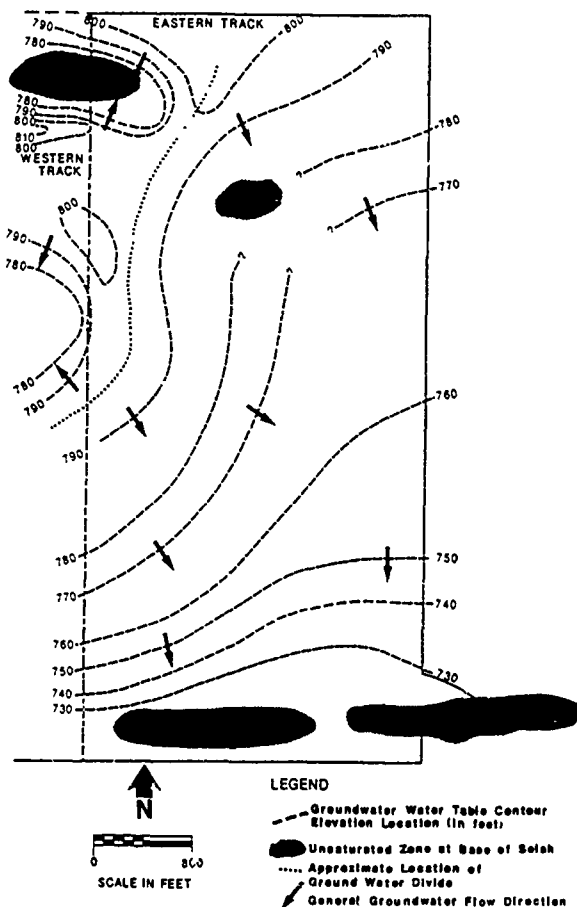
Figure 6 Generalized Groundwater Table Contour Map of Uppermost Aquifer at Base of Selah

Comparison of the water table contour map and the piezometric contour map for the base of the Selah compares favorably although the piezometric contours at the base of the Selah more closely reflects the configuration of the top of the Priest Rapids than do the water table contours (Figures 6 and 7). The piezometric head at the base of the Selah is also lower than that of the water table. This reflects the geologic control on groundwater occurrence and the flow regime within the Selah.

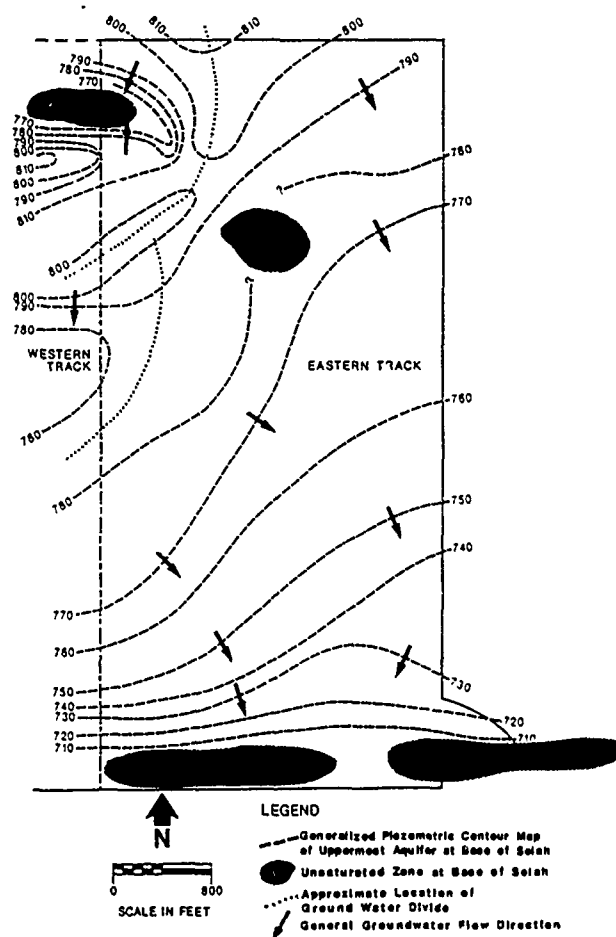
Figure 7 Generalized Piezometric Contour Map of Uppermost Aquifer at Base of Selah

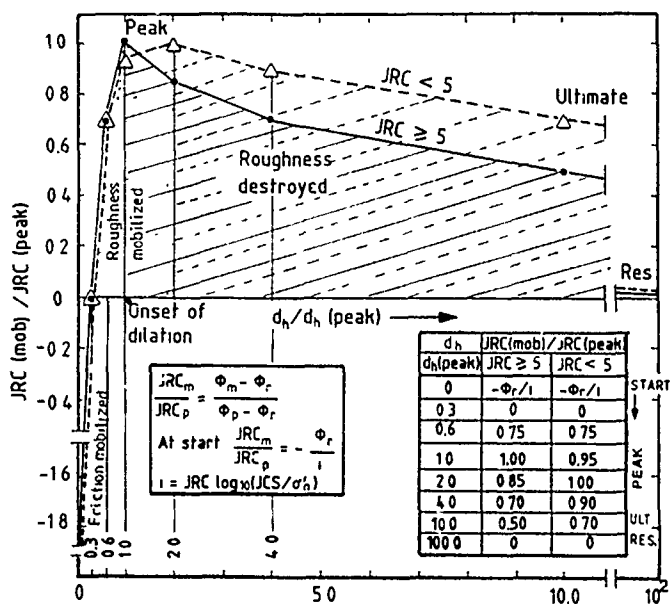
Fig. 1. Dimensionless model of joint shear behaviour (from Barton & Bandis, 1987).

The model illustrated in Fig. 1 simulates the following fundamental features of joint shear behaviour:

- (i) mobilization of the basic frictional resistance, upon initiation of shear
- (ii) the amount of initial shear for roughness mobilization is scale dependent ( $\approx 0.3 * \Delta h_{\text{peak}}$ ).
- (iii) dilation begins when roughness is mobilized.
- (iv) peak shear strength is reached at  $JRC(\text{mob})/JRC(\text{peak})=1.0$  and  $\Delta h/\Delta h(\text{peak})=1.0$ . The peak shear displacement,  $\Delta h(\text{peak})$ , corresponds to 1% of the joint length. A value of  $\Delta h/\Delta h(\text{peak})=2$  has been adopted for relatively smooth and planar joints ( $JRC < 5$ ).
- (v) the contribution of roughness declines in the post - peak region, owing to surface mismatch and wear.
- (vi) the residual state ( $JRC \text{ mob}=0$ ) is reached after large shear displacements ( $\Delta h/\Delta h_{\text{peak}}=100$ ).

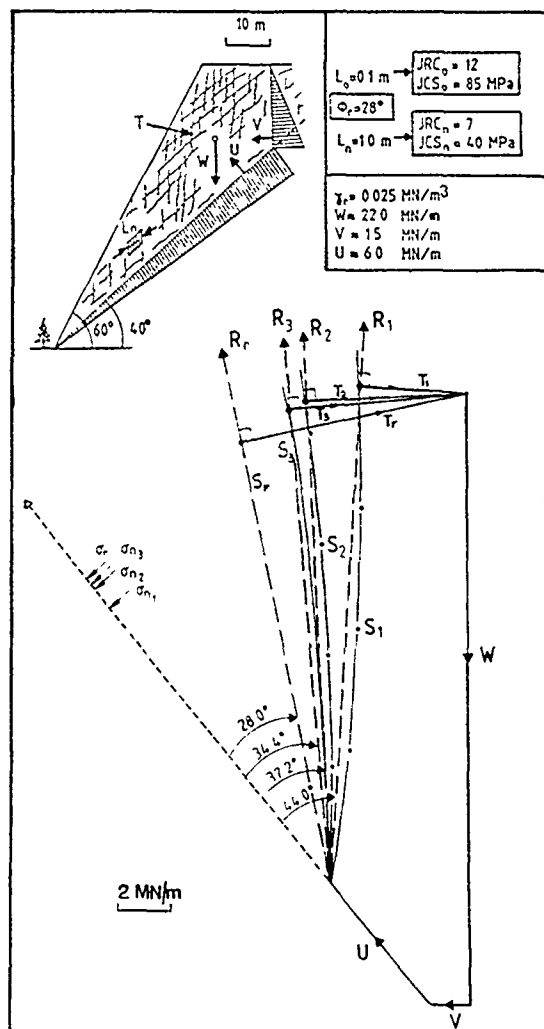
Fig. 3. Example of graphical solution for optimum bolt design using normal stress and scale dependent values of  $\Phi$  (mobilized) (from Bandis et. al. 1985).

Barton and Bakhtar (1983) suggested a graphical solution for optimum bolt design, utilizing normal stress and scale dependent values of  $\Phi$  (mobilized). The technique essentially combines the appropriate "mobilized" strength envelope, with a conventional force diagram.

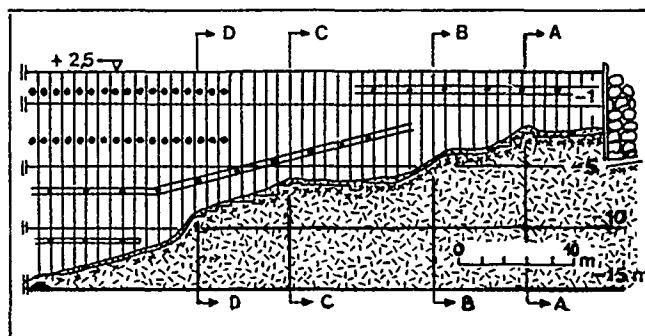
Fig. 6. Vertical section of seawater barrier along the final slope line. A - A, etc. indicate sections of different geometry, which were analyzed.

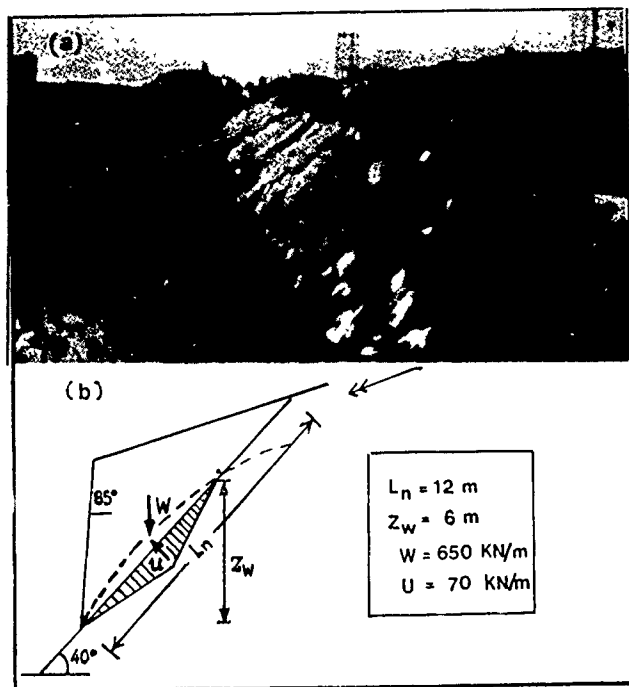
Fig.8 (a) Persistent joint surface along which translational failure took place.  
(b) Conditions assumed for back-analysis of failure.

The exposed failure plane at the rightmost end of the slope (Fig.5), was quite accessible for direct measurements of the surface roughness. Detailed line-profiling along section 2-2 in Fig.8(a) gave the trace presented in Fig.9.

The length of profile in Fig.9 is  $L_n \approx 11.0$  m and  $a \approx 150$  mm. Then, a value of JRCn 6-7 is predicted from the nomogram. The independently derived JRCn value was used to back-calculate the drained friction angle, which was mobilized along the failure plane, as shown in Fig.8:

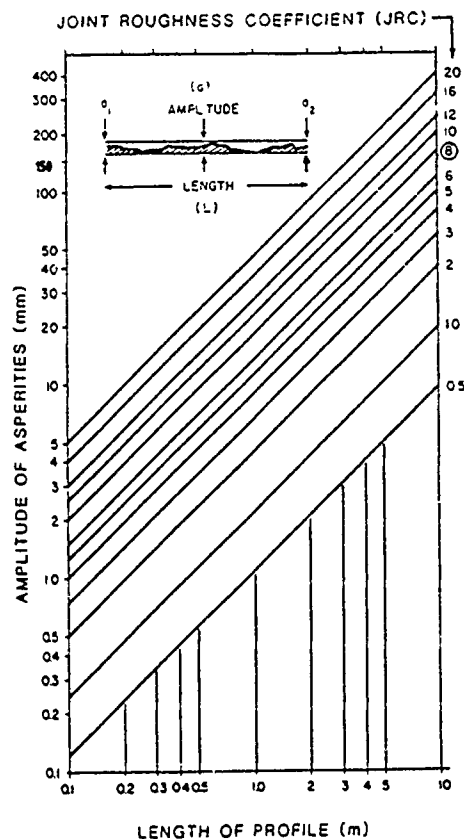
Fig. 10. Joint roughness characterization according to the amplitude of asperities and length of profile. (Barton, 1982).

The value of JRCn characterizing a particular surface, represents an approximate measure of the roughness amplitude ( $a$ ) divided by the length ( $L_n$ ) of the profile. From analyses of a large volume of data, Barton (1982) arrived at the nomogram of Fig.10.

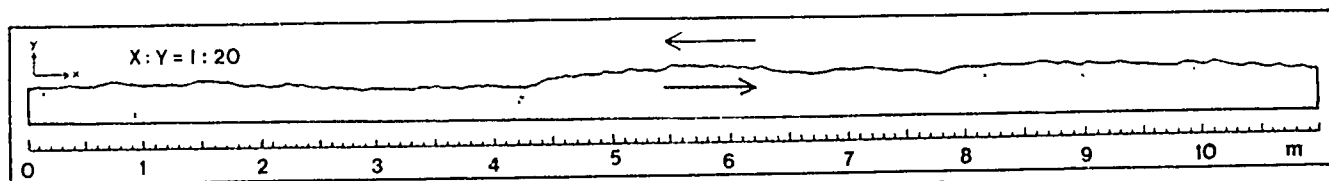
Fig. 9. Roughness profile along section 2-2 in Fig. 8(a).

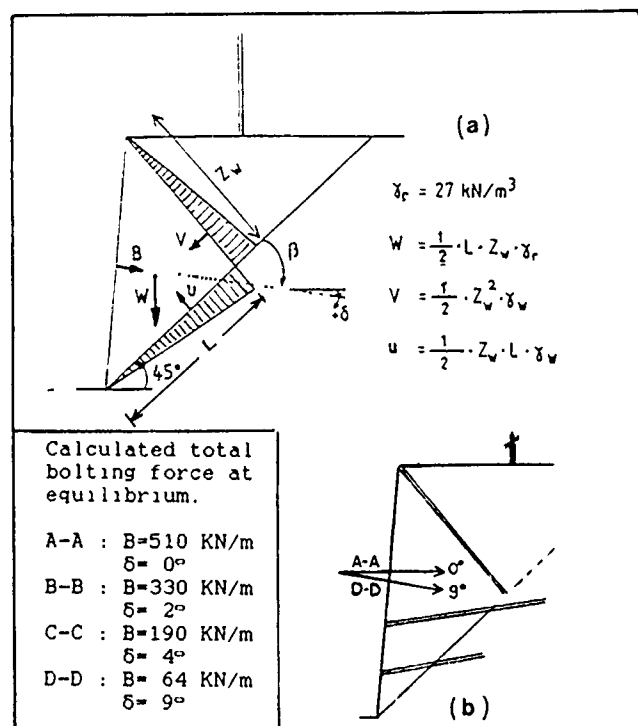
Fig. 12. Illustration of (a) assumed slope geometry forces for bolt design (active pressure from upper slope-half considered equal to zero); (b) recommended bolt direction and position of drainage holes

part of the slope, at the final excavation line. Limiting equilibrium analyses were conducted for the slope sections A-A to D-D, by assuming a tension crack at the zone of potential relaxation and perpendicular to the failure plane, as illustrated in Fig.12(a).

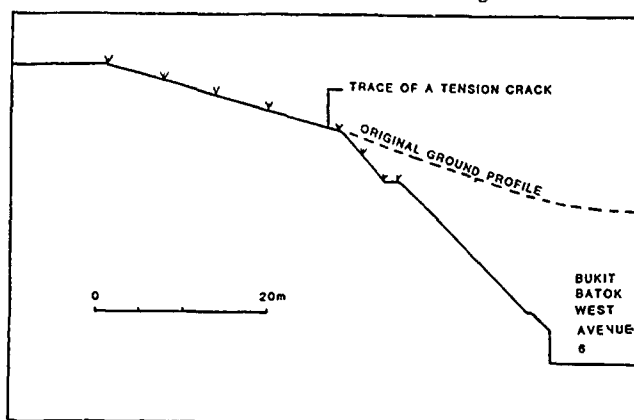
Fig. 3 Profile of the cutting slope

The slope is over 30m high, the lower 23m sloping at about 45° with a 3.7m sub-vertical toe (Figure 3).

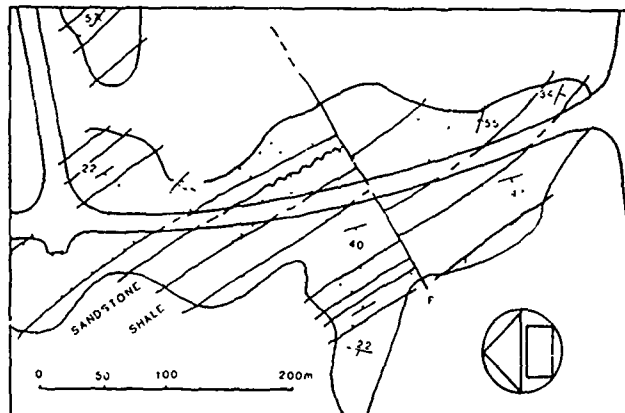
Fig. 7 The geological setting

is a wrench fault (Figure 7) which formed the release surface at the southern limit; F is the joint set mainly responsible for the backscar, although G and H were also involved, and I is the cyclograph of the average dip and dip direction of the bedding from the nearly fifty bedding readings taken. However, because of the gradual change in strike as the toe of the failed part of the slope is approached, this is rather misleading, and there is closer coincidence of the dip direction of the bedding and the slope at this point. The main structures controlling the slide can therefore be seen to come from the master joint sets and the bedding.

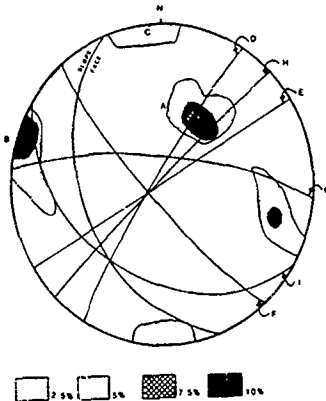
Fig. 9 Stereographic projection of main geological structures

The slope forms part of the eastern limb of an open syncline. The geological structure of the rock mass forming the slope is summarised in the stereographic projection, Figure 9. The plotting of poles of normals to planes was carried out on an equatorial equal area net, and the poles were contoured using a Denness Type B counting net (Denness, 1972). Pole concentration A represents the bedding. There are about fifty readings of bedding, and some scatter in the results was experienced. The reasons for this are probably two fold. Firstly, along the length of the face measured, there was a very gradual change in the strike of the bedding by a few degrees, indicating that the fold was either periclinal, or had been re-folded. Secondly, the roughness of parts of some of the bedding surfaces, seemingly as a result of localised penecontemporaneous erosion, also led to variations in orientation at that scale of measurement. Pole concentrations B and C are joint sets, each one sub-vertical in nature.

Also included on the stereographic projection are cyclographs of the more important sets of discontinuities with respect to the slope failure. Cyclograph D represents the joint set which formed the release surface at the northern limit of the slide; E

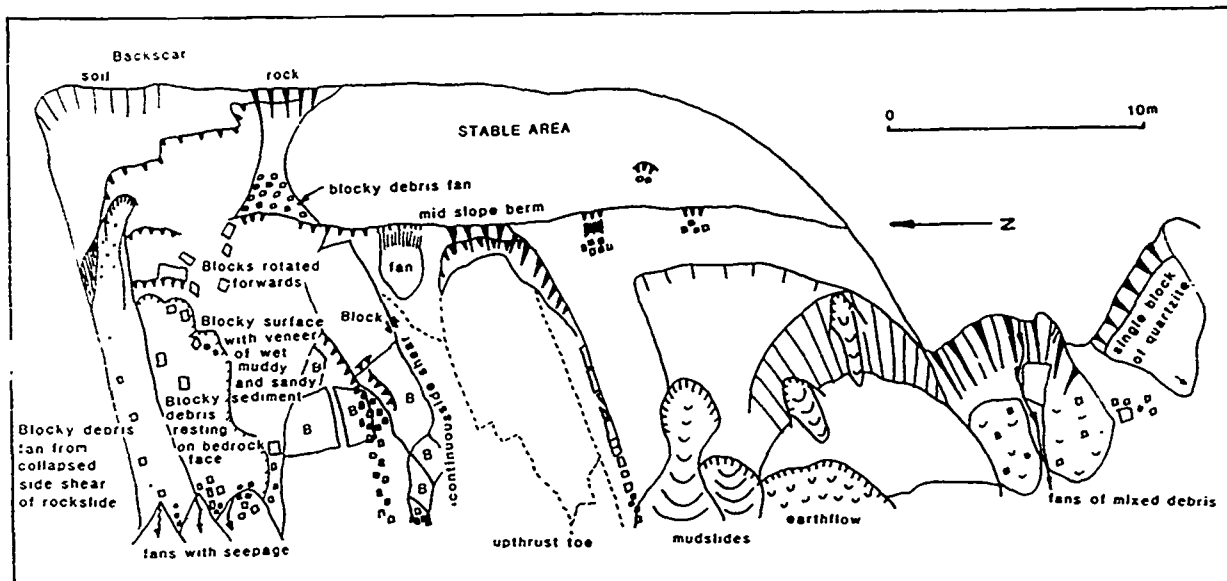
Fig. 17 Geomorphological Map of Slope Failure

A geomorphological map of the slope failure to the south of the main rockslide is shown on Figure 17.

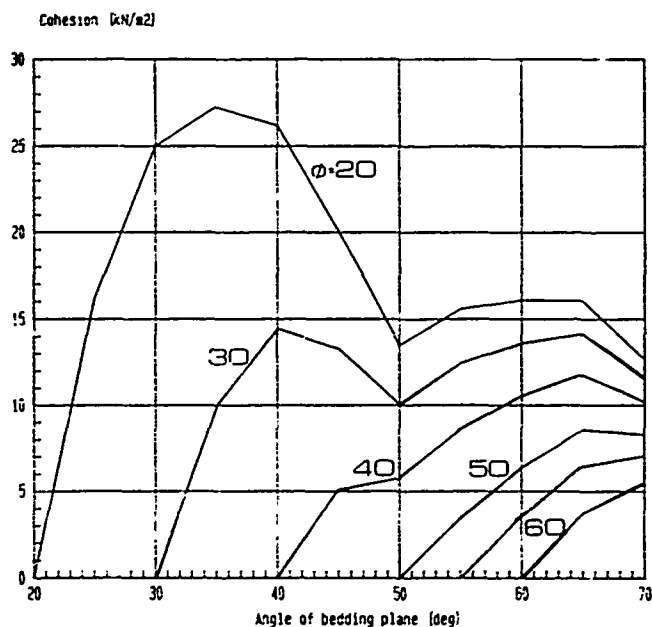
Fig. 18 Results of Stability Analyses. Case 1

The results of the sensitivity analyses for the three cases are shown in Figures 18, 19 and 20.

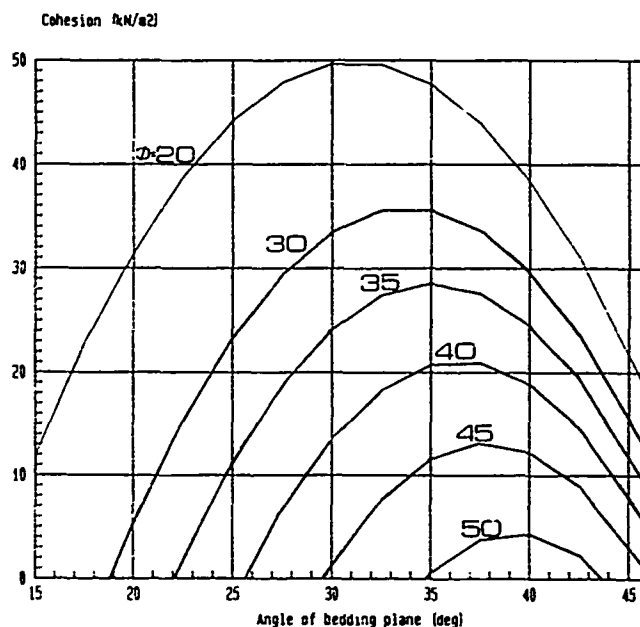
Fig. 20 Results of Stability Analyses. Case 3

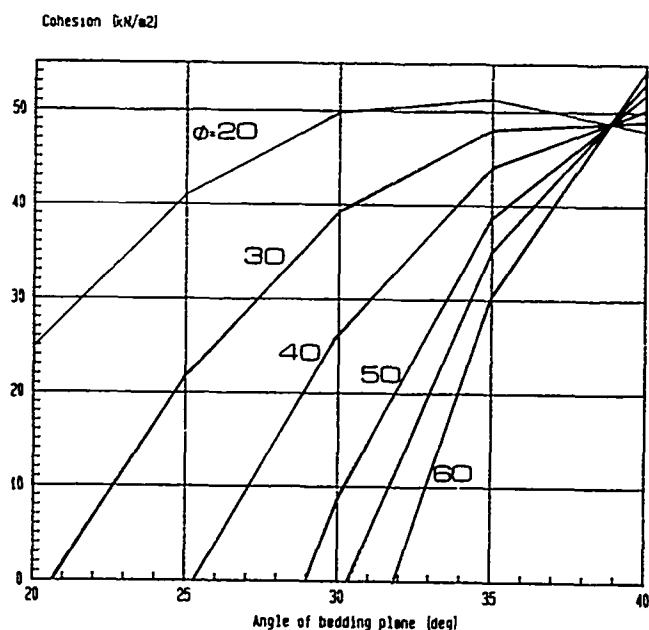
Fig. 19 Results of Stability Analyses. Case 2

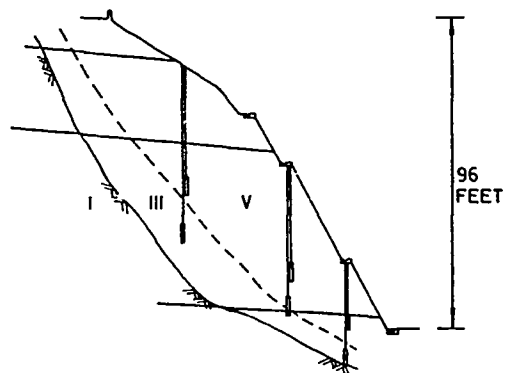
Fig. 1 Lower Slope Section Showing Horizontal Drains and Piezometers

The deeper zones of weathering also exhibited permanent ground water. Horizontal drains installed along the deeper zones of weathering, and the drains which intercept these zones at depth were found to yield a permanent flow of

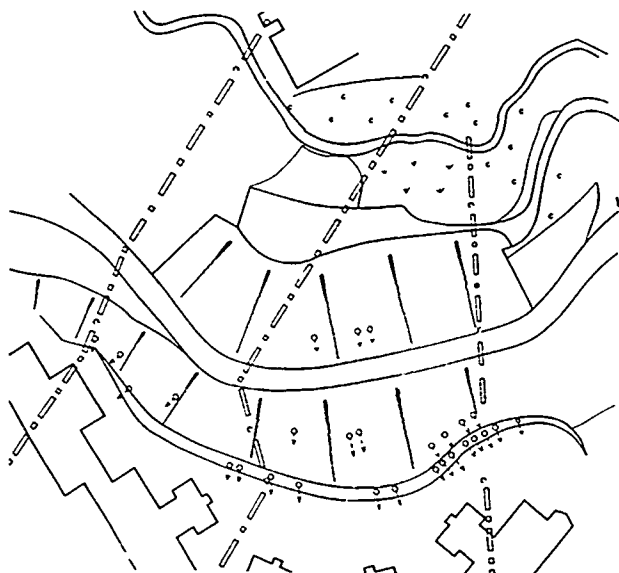
Fig. 2 Site Plan Showing Zones of Deep Weathering

The unusually large number of borings already drilled prior to this study facilitated to the early development of a geological model of the complex subsurface conditions. From the interpretation of aerial photographs, geological site surface mapping, and review of existing borehole data and ground water level monitoring, three major zones of deep weathering were considered to extend across this area (Figure 2). Correlation of field mapping and borehole data suggested that these zones of deeper weathering were probably shear or fracture zones in the rock mass.

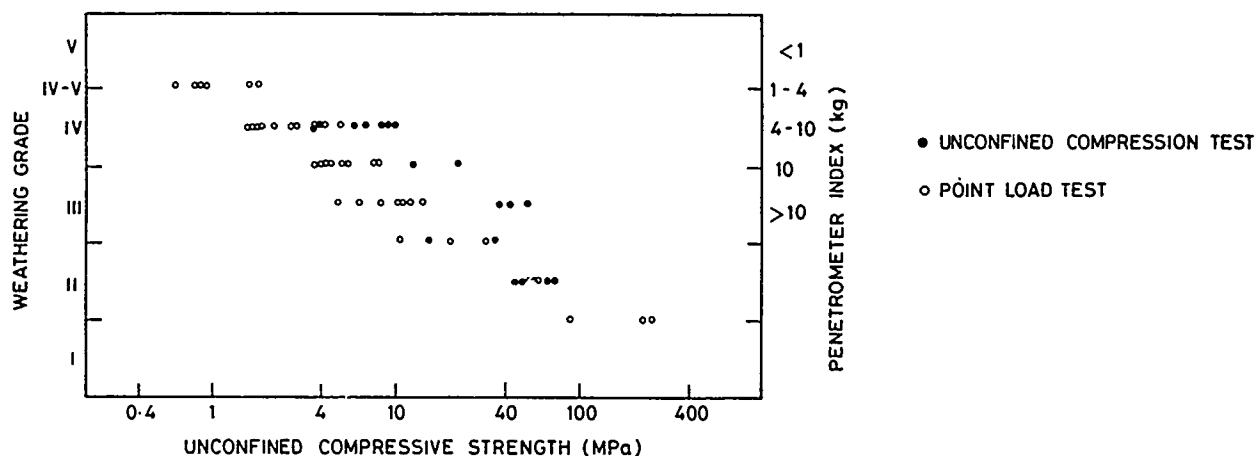
Fig. 3 Index Strength Test Results (After Kwong 1985)

Additional fieldwork was carried out for this study. 12 vertical and 4 horizontal drillholes were each selected for a specific purpose such that the geological features of the site can be defined. During the course of the field exploration, the locations of some of the later holes and test pits were revised as a result of the information obtained from the first few holes and test pits. Core samples of soil, transitional material and rock were obtained using a Mazier retractable triple tube core barrel. Block samples of weathered rocks were collected from trial pits and exposed areas on the existing cut slope. Grades of weathering were classified by visual examination and a pocket penetrometer modified for testing strong materials was used to provide a quantitative index strengths of materials which had undergone different degrees of weathering (Figure 3), (Kwong et al., 1984).

The strength parameters for grade V, transitional, and grade IV materials were obtained by performing consolidated drained triaxial tests on Mazier samples (Figure 5), Table 2. Point load strength tests and unconfined compression tests were carried out using NX size cores, (Figure 3).

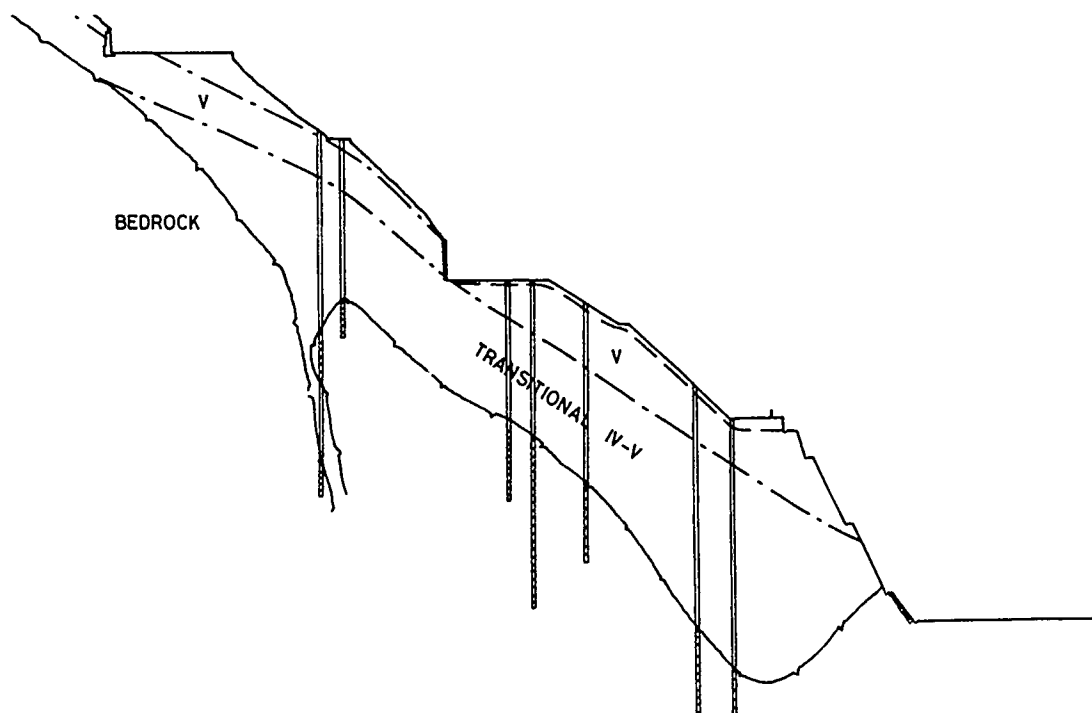
Fig. 4 Cross Section of Slope

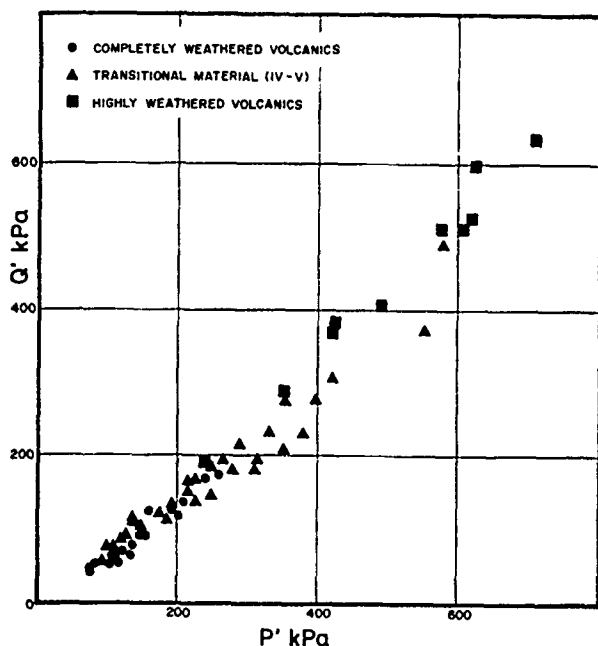
Fig. 5 Triaxial Strength Test Results

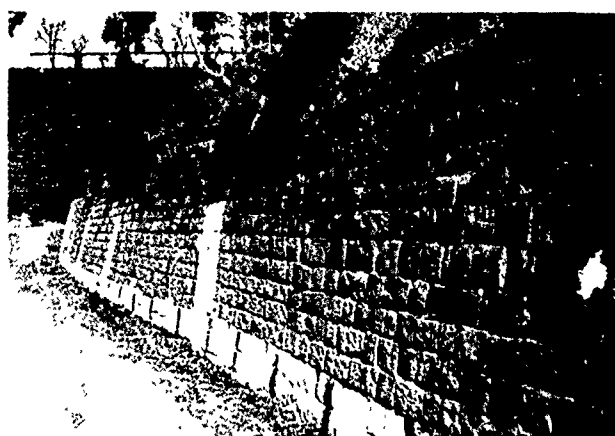
Fig. 9: Reconstructed Foot Wall.

As reported earlier, in the portion between the foot of the hill and the approach road, the slope was in a critical condition. Hence the slope was regraded, the approach road was realigned and the section of the foot wall was improved. The measures stabilised the slope and the reconstructed foot wall showed no sign of distress over last 5-6 years. A recent picture of the wall is shown in Fig.9. Its comparison with Fig.1 speaks of satisfactory functioning of the remedial measures.

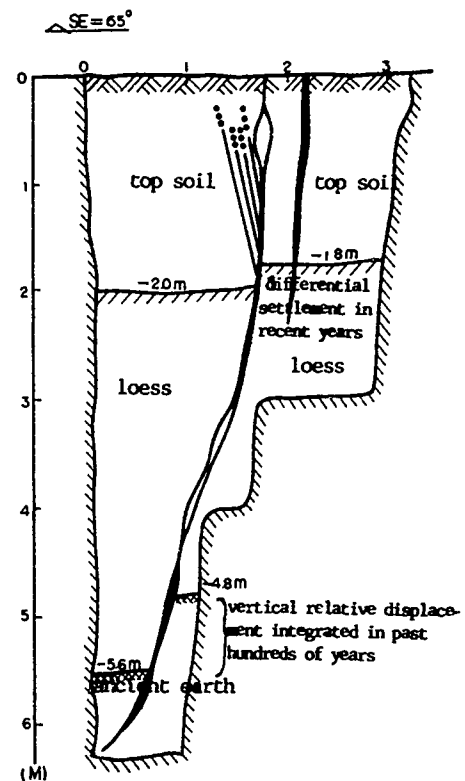
Fig. 3 Profile of a testing pit

with increasing depth(Fig. 3);

By visual observation in exploration trenches at many localities over Xian city, many ancient fractures embedded with top soil at a depth 0.7 - 0.3 m below ground surface were found which were caused by tectonic movement of ground in historical event [4]. Fig. 3 is an example where an ancient fracture belt striking in N 65°-70° E, about 5 - 6 m wide, embedded at 2m depth by top soil. The fractures vanish downward at a depth of 6.5 m. It was verified that the fractures were caused tectonically by Hua-xian earthquake in 1556. It was also noticed that most of the ground ruptures lay on the ancient fractures which were normally filled by the materials from top layer. Very important evidence is that there existed micro-fractures in the top soil directly above the ancient fracture. Since the ground rupture is partially the sequel of ancient fracture in the soil, it is easy to locate the ground rupture by simply digging trenches and identifying whether ancient fracture exist or not.

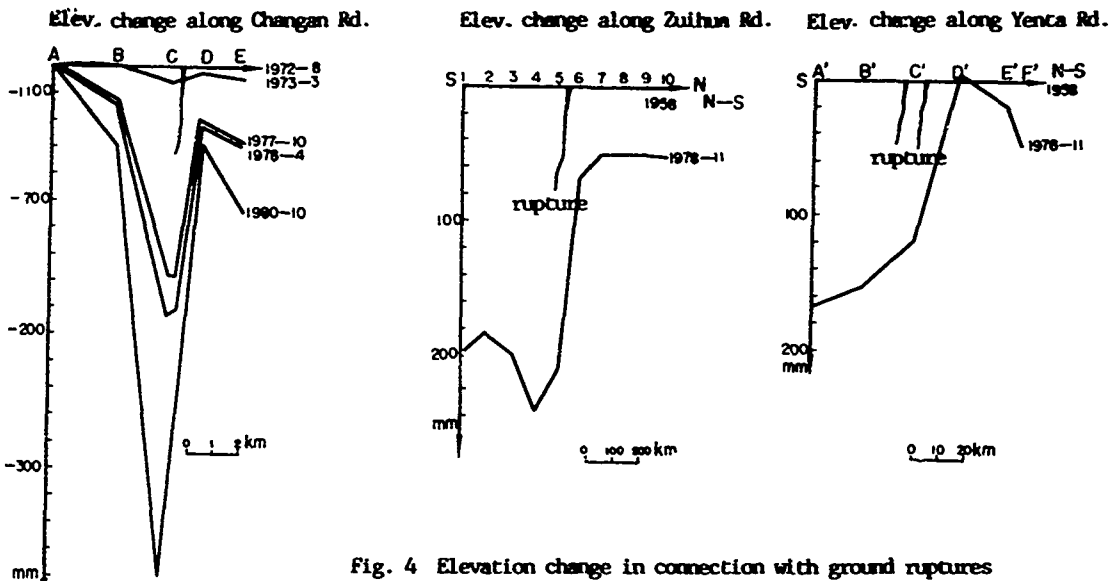
Fig. 4 Elevation change in connection with ground ruptures

(5) All the ground ruptures distributed within the scope of ground subsidence. The most active ruptures are directly associated with the drawn-down of ground water(Fig. 4);

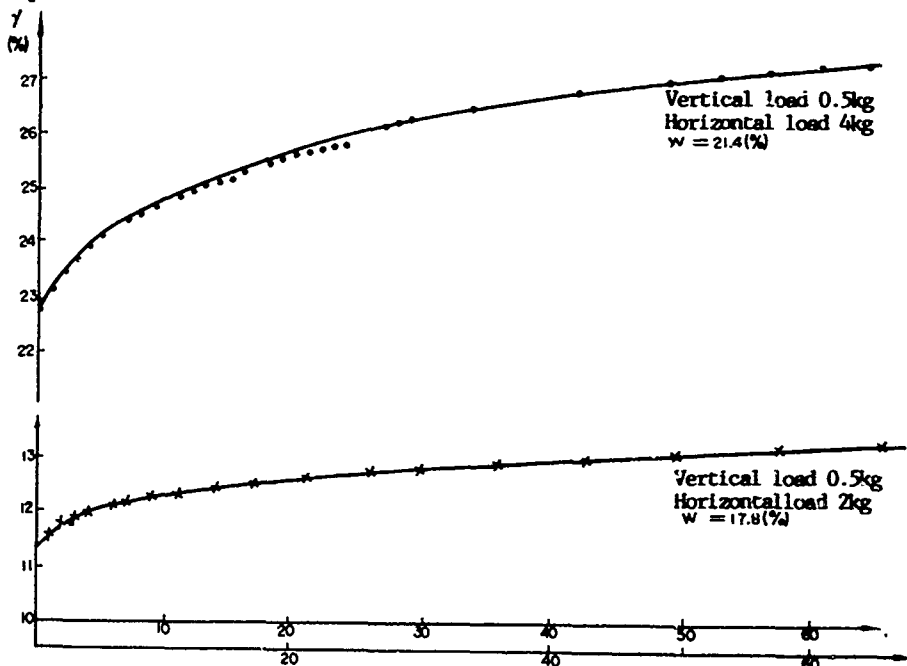
Fig. 5 Shear strain versus time of the material used for the model test

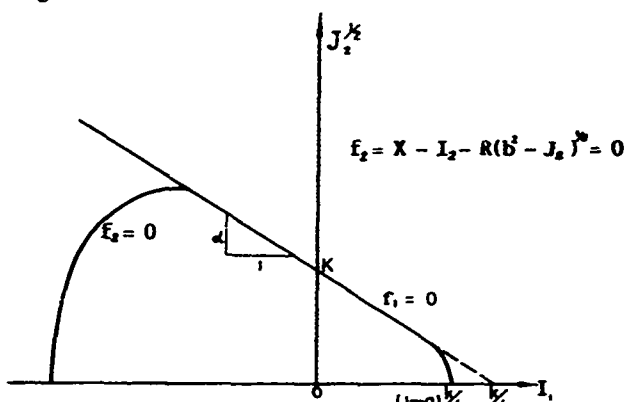
Fig. 6 (A) Cap model

An elastoplastic finite element analysis program was used to figure out the mechanism of the rupture. It has a big variety of elements which lead soil mechanics into plasticity. To modify the soil properties, Cap-model was first put into consideration. Since this model is actually composed of both a cap and a Drucker-Prager yield plane (Fig. 6 A), and the stress path mainly goes along  $f_1$ , and  $f_2$  will become a minor factor, so Drucker-prager model was finally used for simplicity which yielding plane is as shown in Fig. 6 B.

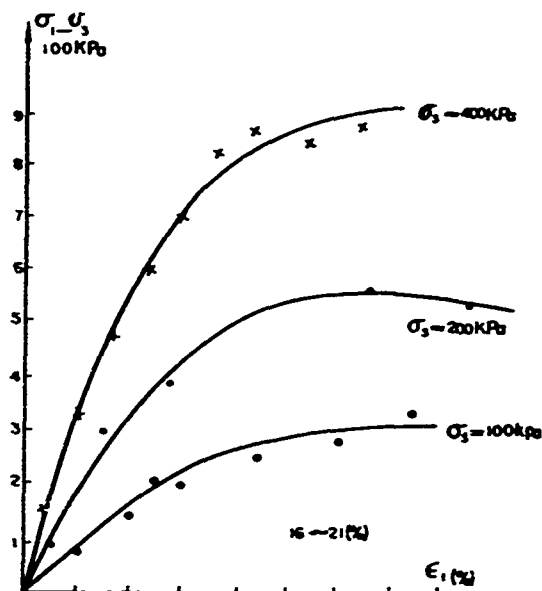
Fig. 7 Stress-strain relationship of the materials used for the model test

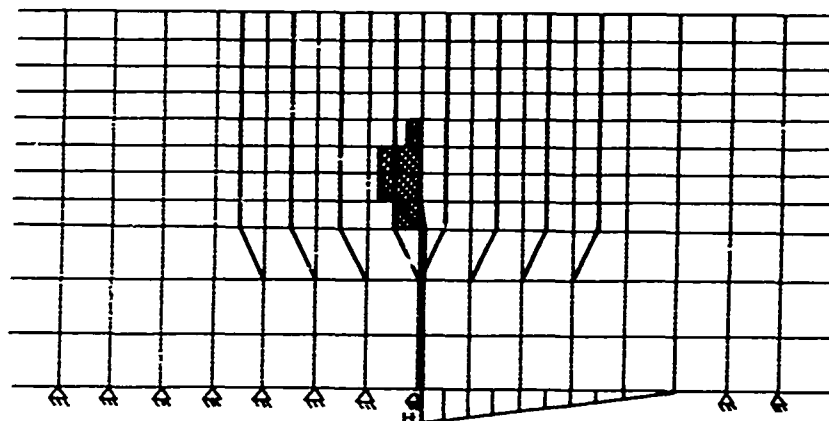
Fig. 8 (A)

H: Displacement input

H = 1/20 of soil thickness

(1) When the ratio of vertical dislocation of bedrock to the thickness of overlying soils is 1/20 (Fig. 8 A) no rupture extends to ground surface until the ratio reaches 1/10 (Fig. 8 B); (2) When dislocation reaches 3/5 of the thickness of overlying soil, the rupture in the soil extend downward, and finally rupture in soil goes thro out the soil layer;

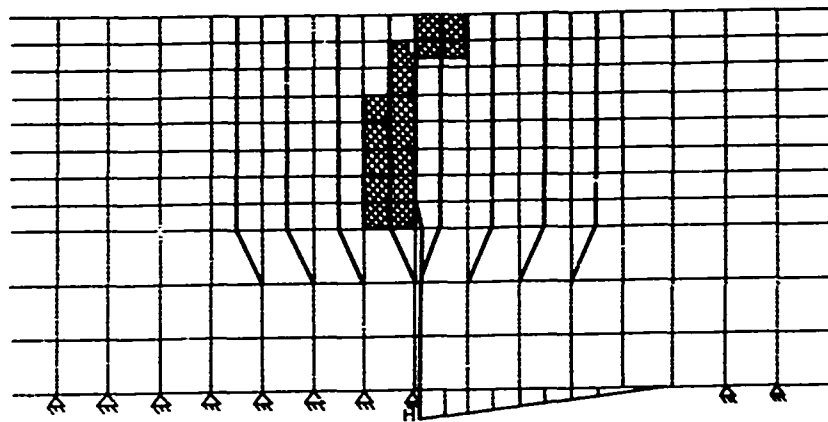
Fig. 8 (B)

H = 1/10 of soil thickness

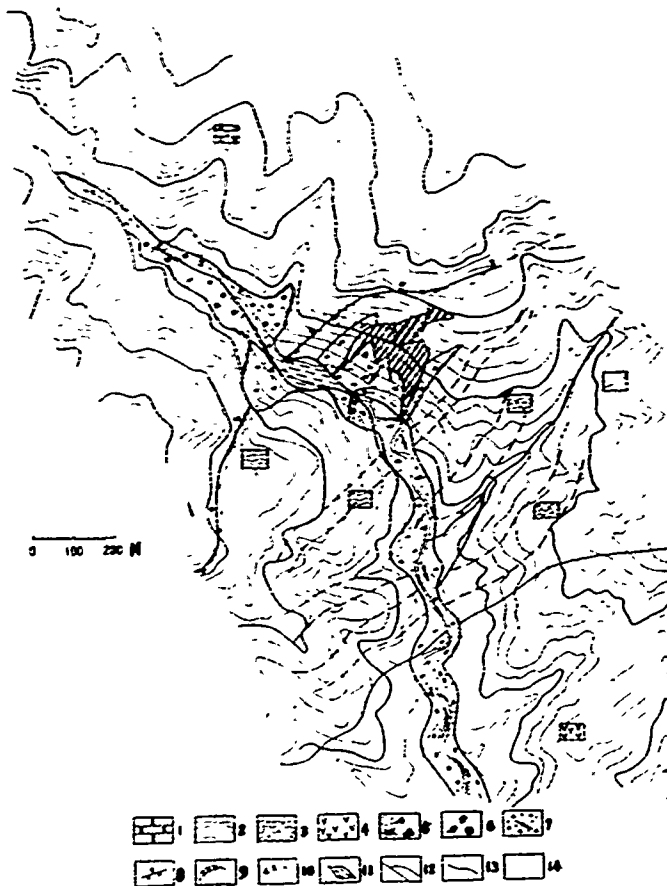
Fig. 1. A geological map of Shi-jia-po section in Ning-qiang county, Shaanxi Province  
1. quartzite, 2. phyllite, 3. chlorite-schist,  
4. basalt-andesite, porphyrite, 5. slope wash,  
6. alluvial soil, 7. sliding accumulation,  
8. fault.

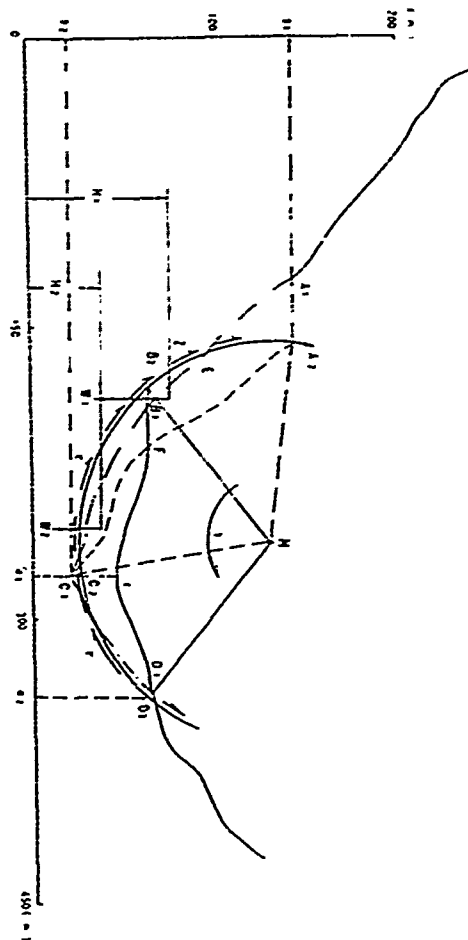
Fig. 3 An analysis map of energy balance of Shi-jia-po landslide

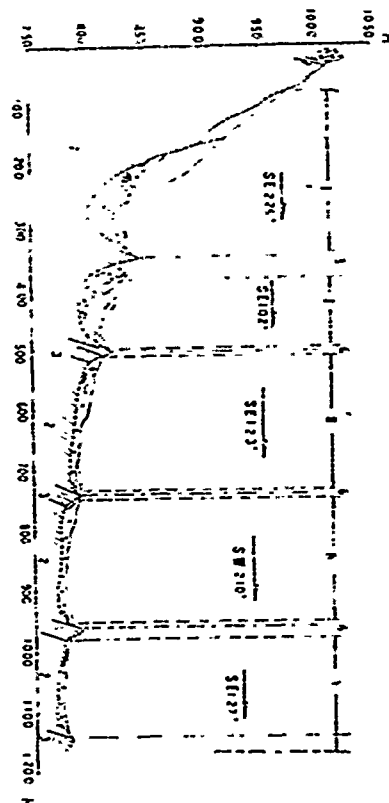
Fig. 4 A process map of multiple-stroke dive and upthrust of Shi-jia-po landslide  
I. the first (sliding) stroke, II. the second (sliding) stroke, III. the third (moving) stroke, IV. the fourth (moving) stroke, V. the fifth (moving) stroke, 1. quartzite, 2. sericite, 3. chlorite-schist, 4. fault, 5. line of former terrains, 6. links.

stated above, it is not different in proving laws of energy conversion of multiple-stroke landslides (Fig. 4, 5).

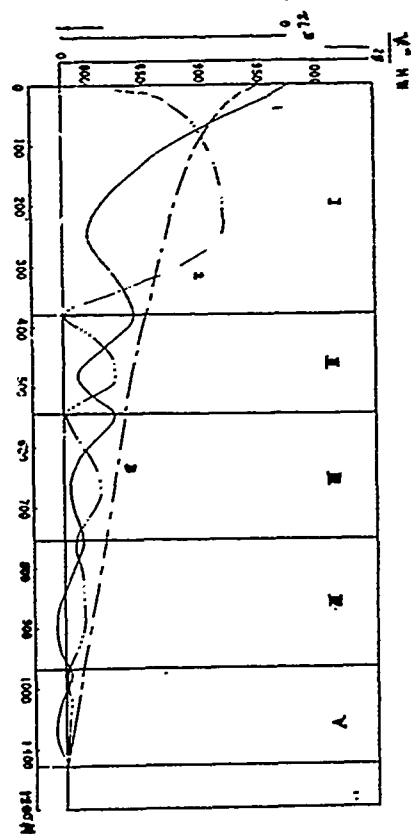
Fig. 5. An inferred map of energy conversion of multiple-stroke Shi-jia-po landslide  
1. curve of potential energy, 2. curve of kinetic energy, 3. curve of energy wasted by friction and resistance.

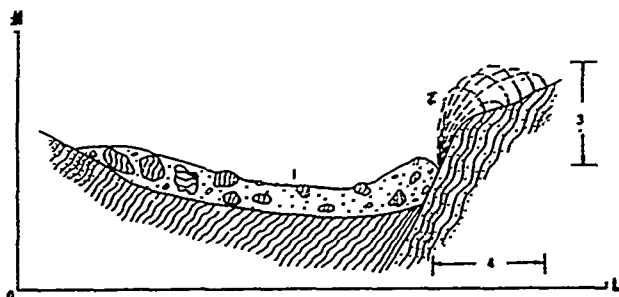
Fig. 6 A sketch map of overstepping gas billows spattered with mud of Shi-jia-po landslide  
1. body slide, 2. overstepping gas billows spattered with mud, 3. the maximum height of spattering ( $h_{max}$ ), 4. the maximum dis-

tance of spattering.

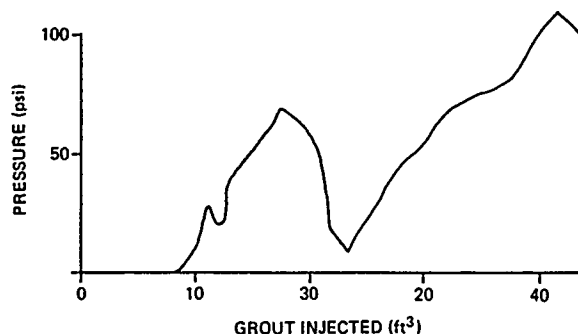
Figure 1. Pressure Behavior at Constant Injection Rate

The injection pressure commonly would build up to two or more peaks during the grouting of an interval, and then would drop off before building back up again. This behavior, an example of which is presented on Figure 1, is ascribed to the grout pushing loose talus blocks aside and exposing additional voids. These pressure peaks were not necessarily high as compared to the refusal pressure for the stage; as is shown on Figure 2, injection of intervals deeper than about 20 feet was more commonly halted on the basis of grout take than of excessive pressure.
